Investigations on the breakdown of a heat recovery steam generator during the initial operation run

D. Bettge*, C. Klinger, D. Klingbeil, A. Eberle

Federal Institute of Materials Research and Testing (BAM), Berlin, Germany

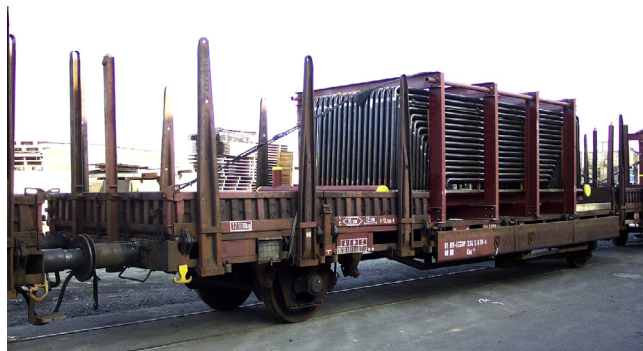
Fig. 5. An evaporator module fixed in a transport cradle and loaded onto a two-axes railroad cargo wagon for shipping. *Source:* customer

A very essential circumstance may be related to the packaging of the evaporator modules. Fig. 4 shows a module fixed on a transport cradle. It may be noticed that between each of two of the stacks a lath has been shoved diagonally. According to the manufacturer this construction, originally used for production as a spacer, was also used for transport to stem vertical shaking or vibration of the pipes.

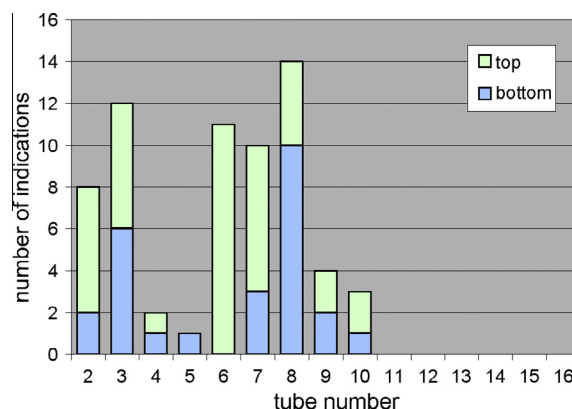
The position-dependent scatter of all cracked tubes which showed leakage was statistically evaluated and the results are shown in the charts of Figs. 7 and 8. The data consider indications for cracks deeper than 0.5 mm. The indications were related to the mounting position of the particular tube within the module. It may be stated that longer tubes were stronger affected than shorter ones. Other criterions referring to the mounting position of the pipe within the unit such as “top/bottom”, “left/right” and “front/back”, were found not to be significant.

Fig. 7. Distribution of crack indications related to the tubes. Small tube numbers means large tube length. Tubes are numbered from “2” to “16” (see Fig. 4). Top elbows and bottom elbows are marked green and blue, respectively. Short tubes (11–16) did not fail.

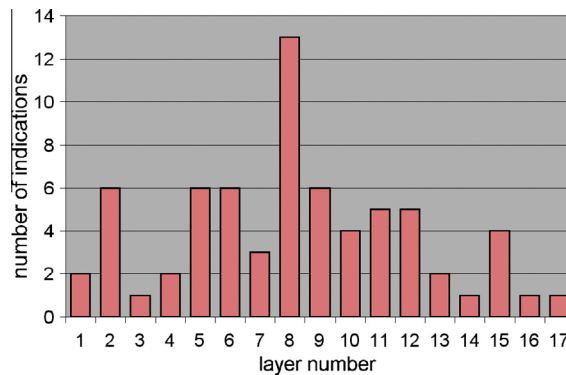
Fig. 8. Distribution of crack indications related to the tube layers (stacks) of the evaporator modules. Layers are numbered “1” to “17”. Layer 9 is located in the centre of the module.

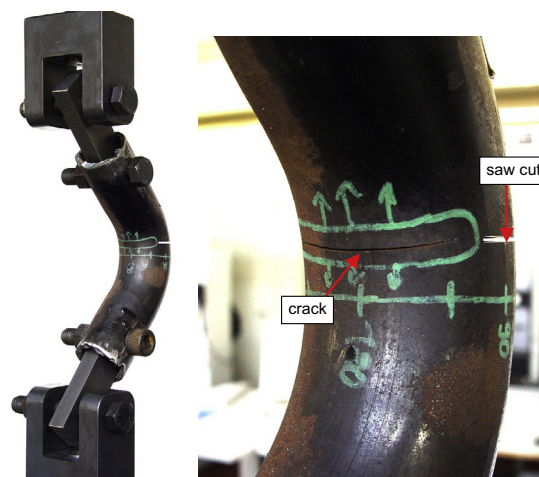
As reported earlier, several cracked pipe bends of specific evaporator tubes were selected and taken away for fractographic evaluation during the on-site inspection. The cracks were mechanically opened using the hydraulic testing system of Fig. 9. In order to do this, the pipe bends were cut off the tubes, and the sections were partially saw cut for the sake of a smaller cross-sectional area to pull apart. After crack opening ever two ring-shaped specimens were cut from one half of the section. Always one of these rings holds the fracture surface. The other ring was used for preparing a metallographic cross section, Fig. 10.

Fig. 9. Opening of a cracked pipe bend in the lab using a servo-hydraulic testing system.

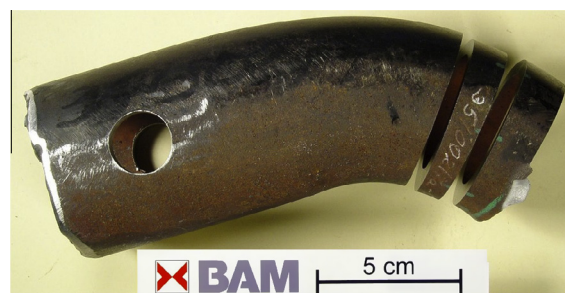
Fig. 10. Part of the pipe bend after crack opening and cutting-off of 2 rings. The ring to the right comprises the crack surface of Fig. 12. The left ring was cut for metallographic investigations, see Fig. 11.

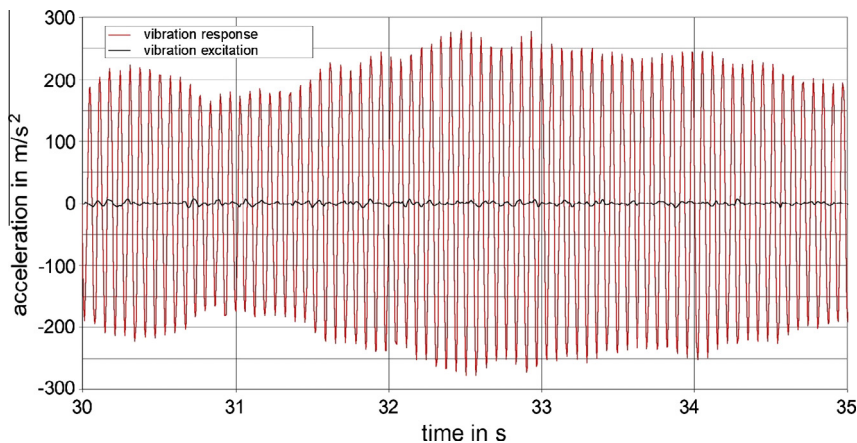
Finite element analysis (FEA) [12] was applied to a complete double-elbow bent tube, connected to a finned wall. The simulation was carried out using fully transient calculation and implicit integration over time similar to [13]. In the simulation, the bent tube was vibrating nearly without damping. Rayleigh damping was introduced and increased until the calculated decay curves showed damping like those measured by the experiments on the tubes of the evaporator modules, compare Sections 2.4 and 5.2. A resonance magnification of about 35 led to high vibration amplitudes even when using small excitation amplitudes as shown in Fig. 19.

Fig. 19. Numerical simulation of the vibrations of an evaporator tube when transported by rail. Vibration response in the middle of the tube (red line) is much higher than vibration excitation at the foot (finned wall) on the rail transport waggon (black line). (For interpretation of the references to colour in this figure legend, the reader is referred to the web version of this article.)

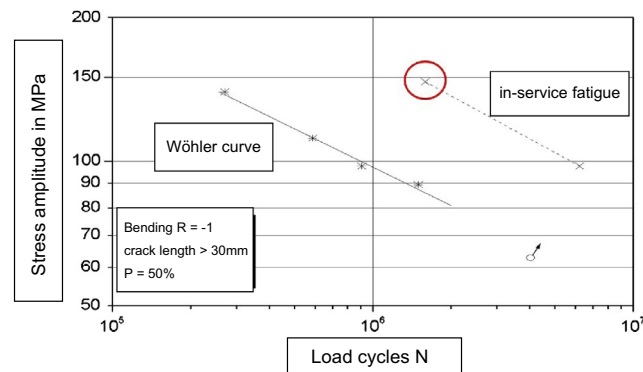
Fig. 21. Results of the fatigue tests using original tube bends.

In the beginning 5 Wöhler experiments with pure sinusoidal stress time history loads were carried out. The results were used to characterise the finite fatigue life strength of the elbow sections, Fig. 21. Furthermore two in-service fatigue tests under Gaussian load spectra, Figs. 21 and 22, were performed. These results were used to characterise the in-service fatigue strength of the tube elbows. The crack size found in the damaged parts was used as the failure criterion for fatigue testing.

When testing with about 100 MPa constant stress amplitude in the Wöhler experiment, the bend cracked almost through the wall at ca. one million cycles, Fig. 21. When using 100 MPa as the maximum stress amplitude and – as in service – a Gaussian load spectrum containing small amplitudes, too, the bend withstood almost 7 million load cycles, Fig. 21.

The test bend of the in-service fatigue strength test marked red¹ in Fig. 21 survived 1.6 million load cycles at a maximum stress amplitude of almost 150 MPa. Compared to the load cycles that were estimated to accumulate damage during rail transportation, compare Section 5.2, initiation of fatigue cracks due to vibrations during rail transport now seemed to be probable.

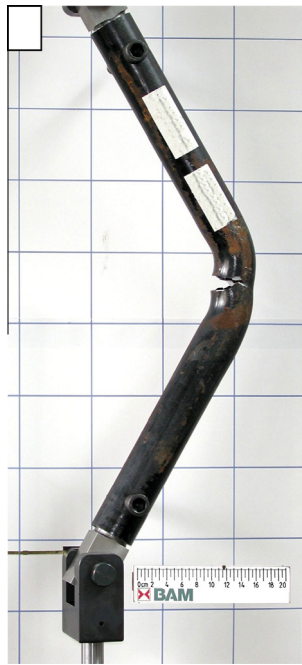
Fig. 22. Fatigue test of an elbow section. State after fatigue cracking and subsequent forced opening of the crack.

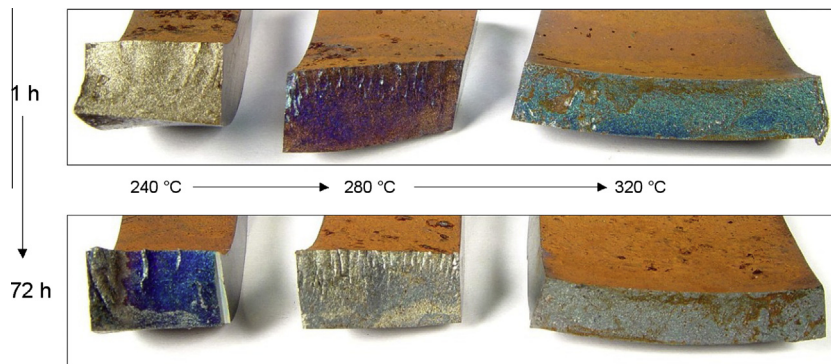
Fig. 23. Annealing colours on laboratory forced fractures after treatment in a furnace in air atmosphere; colour depending on time and temperature.

In order to find adequate limits for temperatures and annealing times, pre-tests were carried out on small laboratory forced fracture surfaces, Fig. 23. Data recording during the initial test run of the steam generator pointed to temperatures between 200 °C and 240 °C applied for drying the steam generator. To achieve annealing colours similar to that seen in Fig. 13, a heat treatment of 72 h at 240 °C was carried out, Fig. 24 top. Whenever the fatigue test was continued after the heat treatment, further effects such as formation of fretting were observed, Fig. 24 bottom.

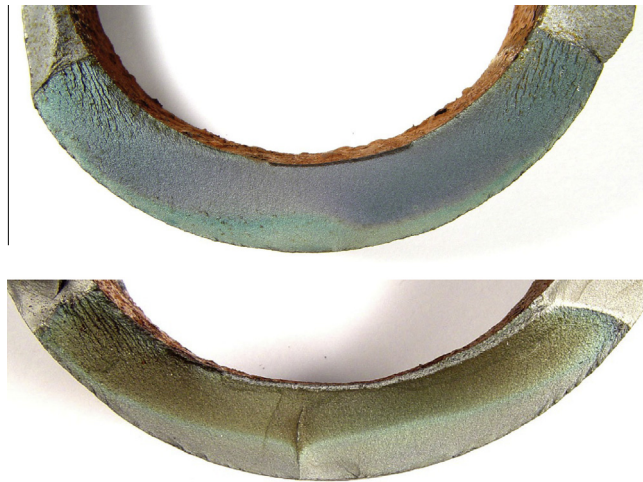
Fig. 24. Fracture surfaces of beforehand undamaged tube bends after laboratory mechanical fatigue test, followed by heating in a furnace and subsequent opening (upper specimen). Lower specimen was mechanically cycled after annealing and then opened.

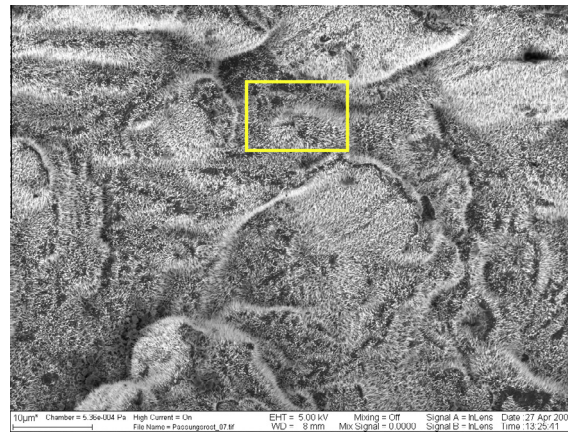
On the annealed crack surfaces of the components tested as abovementioned, here and there some kind of porous coating was found using the SEM at normal magnifications, Fig. 27. At a much higher magnification, Fig. 28, some kind of whiskers was resolved on the crack surface. The whiskers were observed to be damaged by the electron beam of the SEM when imaged for more than some seconds. They were too small to be analysed using EDX. When re-investigating the original crack surfaces from the failure event with these pictures in mind, such a structure was found too, Figs. 25 and 26. Not all of the investigated fracture surfaces exhibited whiskers as may be clearly seen in these images. According to the literature the whiskers consist of iron oxide and grow on the surface when annealed in air, [14,15]. The whiskers found on the cracks of the elbow bends seem to grow under specific conditions in the slightly opened crack.

Fig. 27. Part of the fatigue fracture surface of a comparative component test after annealing. The crack surface is coated with small iron oxide whiskers grown during heat treatment in a furnace with ambient atmosphere.

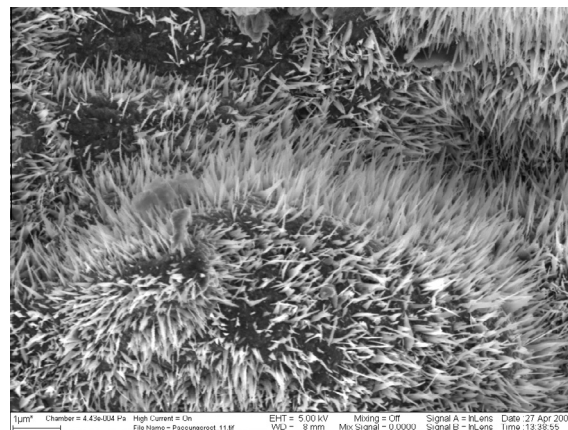
Fig. 28. Enlargement from Fig. 27. Iron oxide whiskers on the crack surface after annealing.
